HA-1592

Ensor Farm

Capsule-Summary

INVENTORY FORM FOR STATE HISTORIC SITES SURVEY

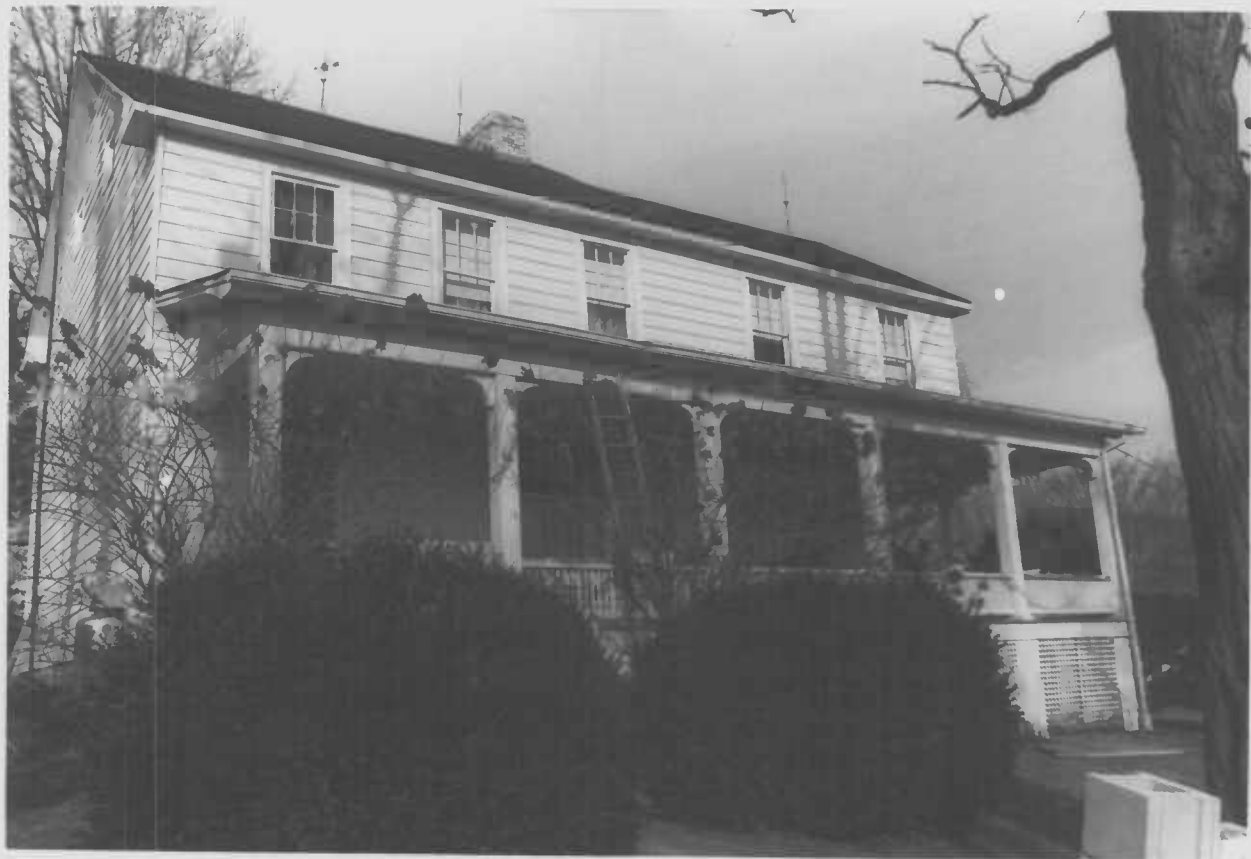
HA-1592

House-south elevation

Residence-- This is a two story gable end (roof runs east-west) structure that faces south and has a side hall plan. Fenestration is irregular. The main block is three bays wide by two bays deep. There is a one story shed roof porch on the south elevation. The present roof covering and exterior siding are of modern materials, and the foundation is of rubblestone. An examination of the basement and adjacent crawl space revealed puncheons. The framing system for this house is probably post and beam, but a particularly thick wall in the east end, where the house may have once been only 1 1/2 half stories high suggests a possibility of some log construction. The house has at least two periods of 19th cent. construction, but alterations made it difficult to determine the complete evolution. The interior plan is a side hall with double parlors.

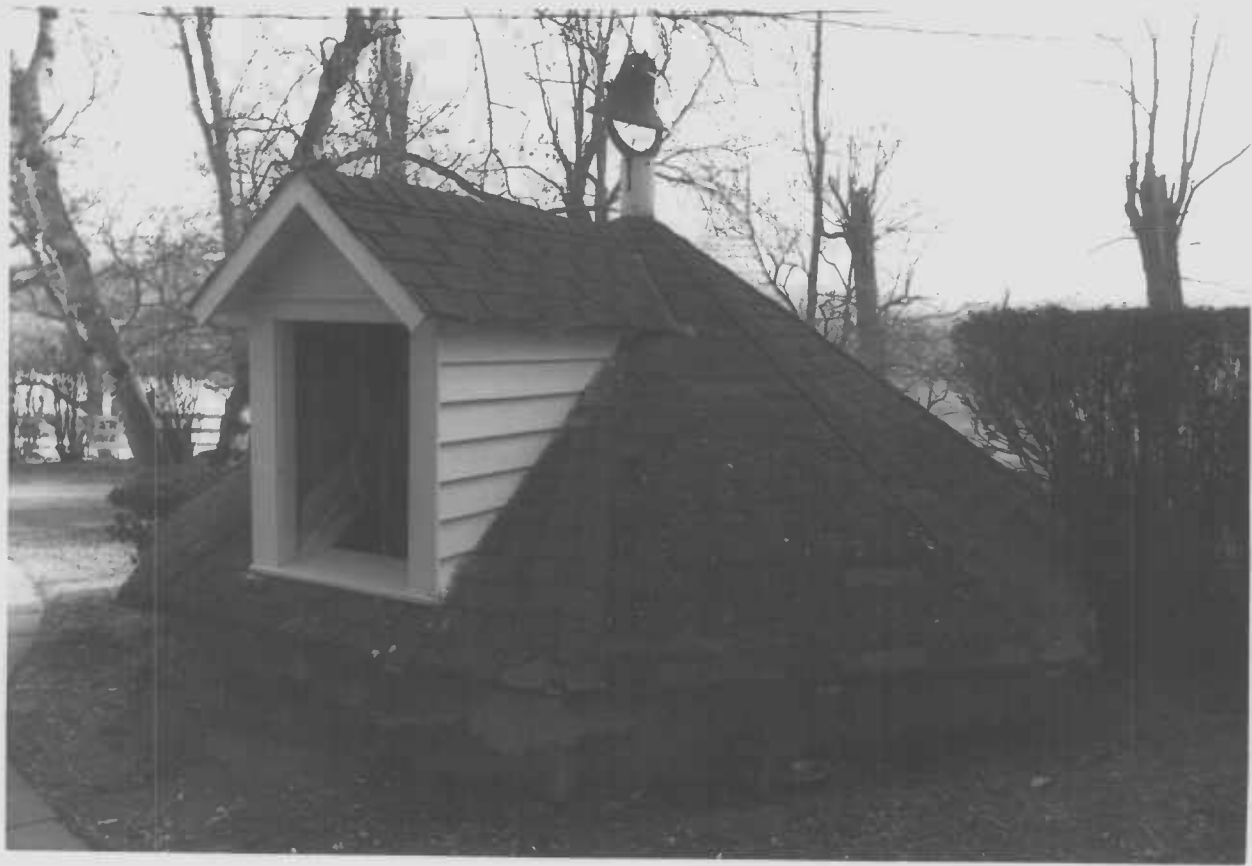
Ensor Farm HA-1592

Icehouse-northwest

Ice house-- This has an octagonal roof and is of course located primarily below ground. The concrete walls suggest an early 20th century construction date.

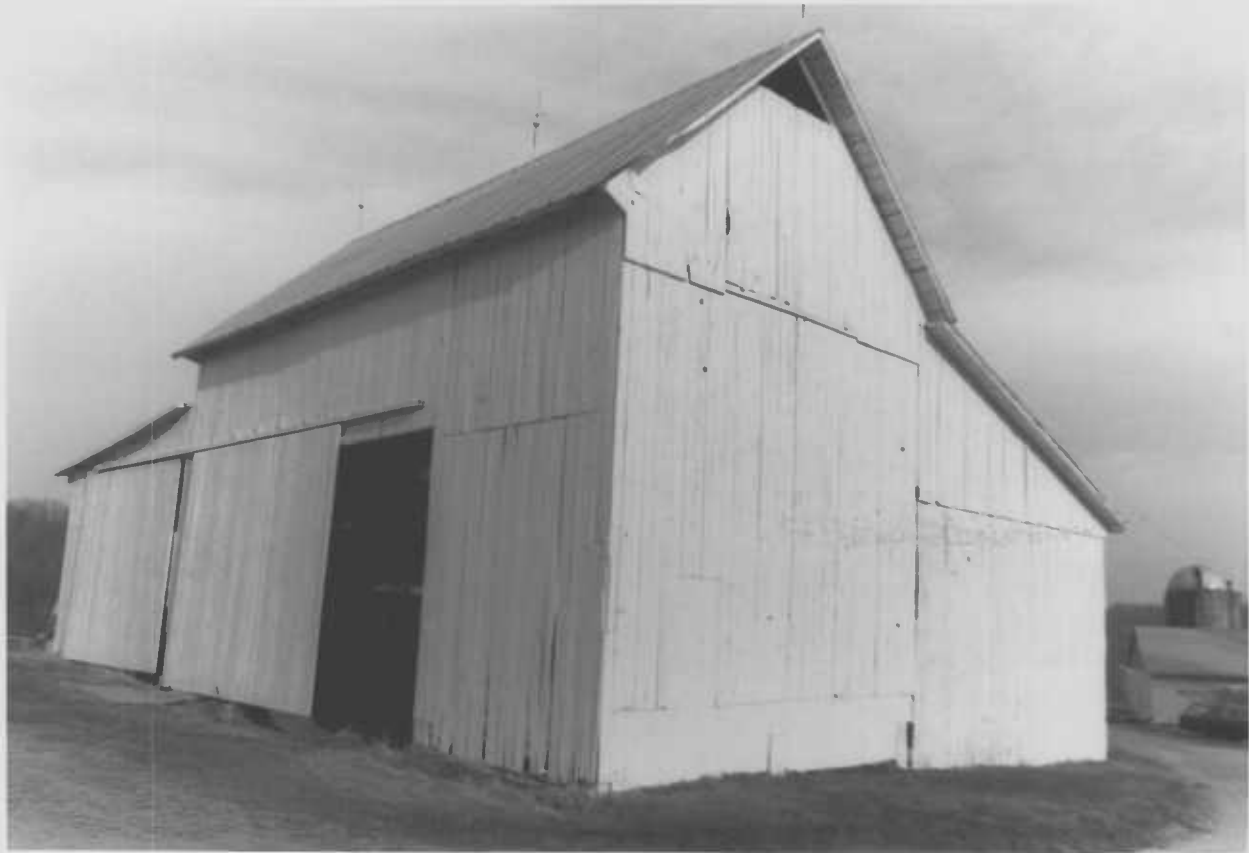
HA-1592

Barn-southwest

Barn--The oldest barn was examined. This is a post 1890's bank barn with a circular sawn post and beam frame. The south wall plates in this barn are scarfed, but one piece measured an entire 40' in length. The barn has tongue and groove vertical siding 7" wide cut to imitate 3 1/2" planks, fastened with cut nails. Rafters are circular sawn 2" x 6" mitred at the ridge (no ridgepole) on 2' centers. The rafters are square notched to fit over the plate. Also on the farm are a large concrete block dairy barn, a frame hayhouse, and smaller modern buildings.
